# BELZONA REPAIR TO CLARIFIER SHAFT IS MOLDED

ID: 1356

Industry: General Industry  
Application: MPT-Mechanical Power Transmission

Customer Location: Machine shop, Gulf Coast  
Application Date: June 2009

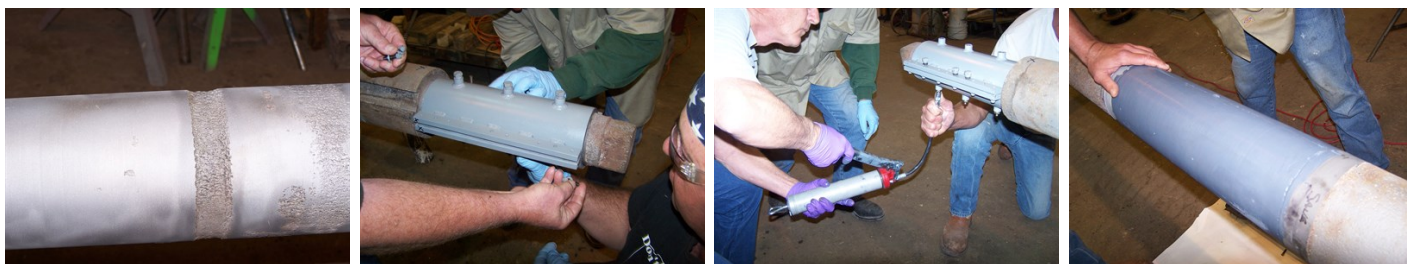
## Photograph Descriptions

Bearing fit deteriorated due to chemical attack and abrasion. Customer needed clarifier back in service as quickly as possible.

- \* The worn shaft ,
- \* Installing the former ,
- \* Injecting Belzona® 1391 ,
- \* Finished and shaft ready to put back in service. ,

Cutlass bearing area on clarifier shaft

Application was carried out in accordance with Belzona Know-How System Leaflet MPT-2. Former was made to mold Belzona to correct diameter. Belzona was injected into the mold.
