BELZONA REPAIR TO CLARIFIER SHAFT IS MOLDED

ID: 1356

Cutlass bearing area on clarifier shaft

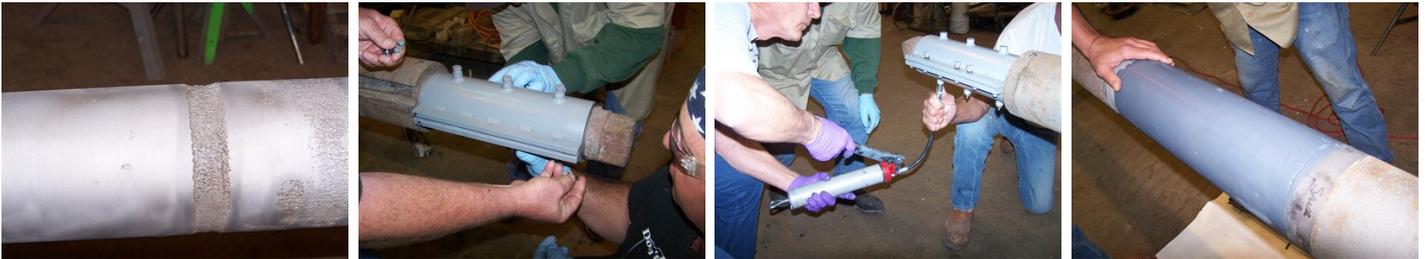
Photograph Descriptions

Bearing fit deteriorated due to chemical attack and abrasion. Customer needed clarifier back in service as quickly as possible.

- * The worn shaft ,
- * Installing the former ,
- * Injecting Belzona® 1391 ,
- * Finished and shaft ready to put back in service. ,

Application was carried out in accordance with Belzona Know-How System Leaflet MPT-2. Former was made to mold Belzona to correct diameter. Belzona was injected into the mold.
