# BELZONA REPAIRS MAIN COOLING WATER SYSTEM FLANGE

Customer Location: Nuclear Power Station, UK  
Application Date: September 2009

Flange on seawater intake pipe of cooling system for nuclear power station

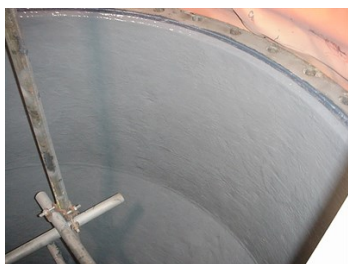
- \* Belzona® 1321 coating on puddle pipe ,
- \* Application of the Belzona® 1111 ,
- \* Machining of the cured Belzona® 1111 ,
- \* The completed application ,

This application follows the successful coating of the pipe internals with Belzona® 1321 in 2006. After 3 years this coating had been found to be in excellent condition, when this problem arose Belzona was the first and obvious choice. Belzona has been used many times to repair damaged flanges. The only alternative available to the client was to prefabricate the spool which represented unacceptable down-time.

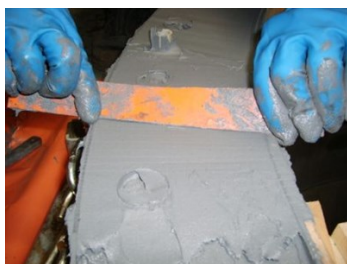
A new spool had been manufactured to connect the intake pipe to the rest of the cooling water system. During welding, the flange on this spool had become warped and following the subsequent machining was found to be up to 9mm undersized.

The application was carried out in accordance with Belzona Know-How System Leaflet VPF-13. After applying the Belzona proud, on-site machining was used to achieve correct dimensions.
