# BELZONA RESTORES RIVER WATER PUMP

ID: 1362

Application: CEP-Centrifugal Pumps

Customer Location: Water treatment works, Iowa

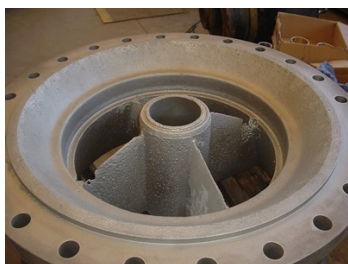
Erosion corrosion caused by sand and solids drawn from the river.

- \* Damaged area on pump ,
- \* Repairs underway with Belzona® 1111 ,
- \* Rebuild completed with Belzona® 1111 ,
- \* Completed application after application of Belzona® 1321 ,
