PUMP BELL CASING REPAIRED AND PROTECTED WITH A LONG TERM BELZONA SOLUTION

ID: 1369

Sea water cooling system pump for a 60 MW turbine.

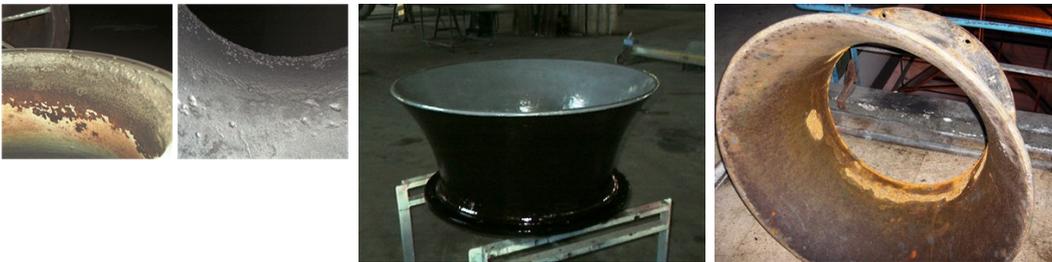
Photograph Descriptions

Efficiency losses and pump breakdown due to severe erosion-corrosion of the single vertical axial flow pump (7090 m³/h). Prior to the Belzona solution the client had to replace or repair the pump components annually. As a significant local electricity supplier, downtime of this critical equipment caused major problems.

- * Original system after 1 year in service ,
- * The finished Belzona application ,
- * Cavitation damage in the swept area ,
- * Ready to go back into service after touch up ,

The original bell lining was failing on an annual basis, leading to pitting corrosion and regular replacement. The Belzona repair vastly

improved reliability and performance. The pump casing, liner and diffuser were also repaired and coated, internally and externally. Yearly touch up is required of the sacrificial coating in the swept area due to cavitation damage. original Belzona protected bellmouth still in service after nine years.

The application was carried out in accordance with Belzona Know-How System Leaflets CEP-5, CEP-3 and CEP-4.
