# BELZONA REPAIRS CASTING DEFECTS

ID: 1375

Application: CEP-Centrifugal Pumps

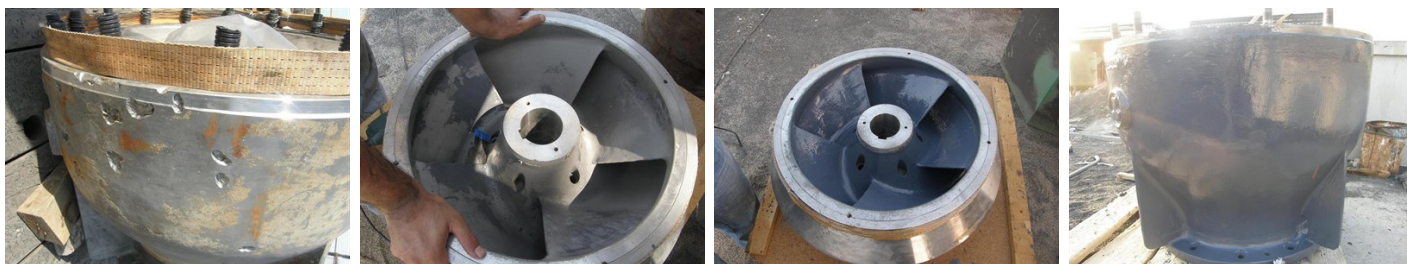
## Photograph Descriptions

*There were several holes on body and blade surfaces after 4 months working due to bad casting*

- \* Holes in pump body clearly visible ,
- \* Rebuilding of impeller blades with Belzona® 1311 ,
- \* Impeller coated with Belzona® 1321 ,
- \* Pump mbody coated ,

Application was carried out in accordance with Belzona Know-How System Leaflets CEP-3 and -5.

Welding was considered but would have taken far longer and cost many times more than Belzona solution.
