BELZONA REPAIRS CASTING DEFECTS

Application: CEP-Centrifugal Pumps

Customer Location: Steel mill, Iran

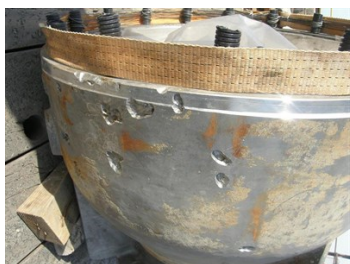
There were several holes on body and blade surfaces after 4 months working due to bad casting

- * Holes in pump body clearly visible ,
- * Rebuilding of impeller blades with Belzona® 1311 ,
- * Impeller coated with Belzona® 1321 ,
- * Pump mbody coated ,
