BELZONA KITCHEN REPAIR KEEPS THE STUDENTS GOING

Industry: Buildings & Structures
Application: FPA-Floor Problem Areas
Substrate: Metal, concrete and tiles
Products: * Belzona® 4111 (Magma Quartz) ,

Customer Location: University, France
Application Date: June 2004

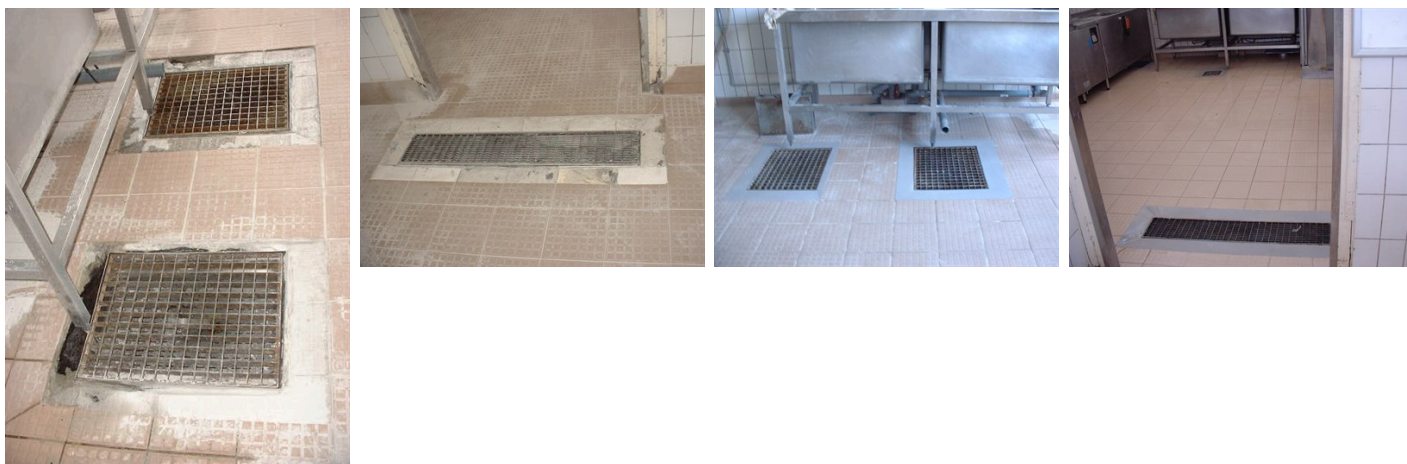
Photograph Descriptions

The tiles were degraded around the stainless steel grate. Following a health and safety inspection, the hygiene of the kitchen was reported so urgent action needed to be taken.

- * Application situation 1 before repair ,
- * Application situation 2 before repair ,
- * Application situation 1 after repair ,
- * Application situation 2 after repair ,

The application was carried out following the Belzona Know-How System Leaflet FPA-1.

tile). The easy to clean surface, proven to be a hygienic solution. It is also resistant to the cleaning liquids used. The Belzona® 4111 is resistant to the pedestrian & trolley traffic in this environment and after 5 years in service, the repair is still in perfect condition.
