# Reconstrucción de forro (liner) interno de Slurry Tank

Industria: Energía

Ubicación del cliente: Planta Generadora Eléctrica, Guatemala C. A.

Solicitud: Maquinaria de Manejo de Sólidos

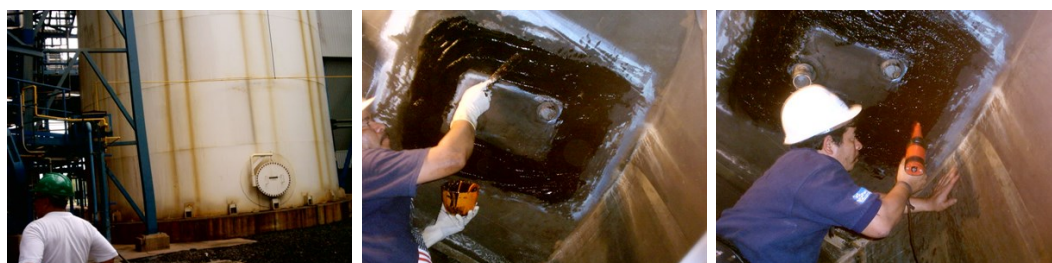
Personal de mantenimiento no se percató que el tanque poseía forro (liner) interno y abrió un manhole en la parte superior.

- \* Tanque de slurrys ,
- \* Aplicando Belzona ,
- \* Revisi&oacute;n con spark tester ,

Tanque agitador de lodos con capacidad de 22,000 galones.

De acuerdo a las Instrucciones de Uso Belzona SHM-9.
