BELZONA REBUILDS BEARING PLATES ON VERTICAL BORER

ID: 139

Craven 90" dia. Vertical Borer

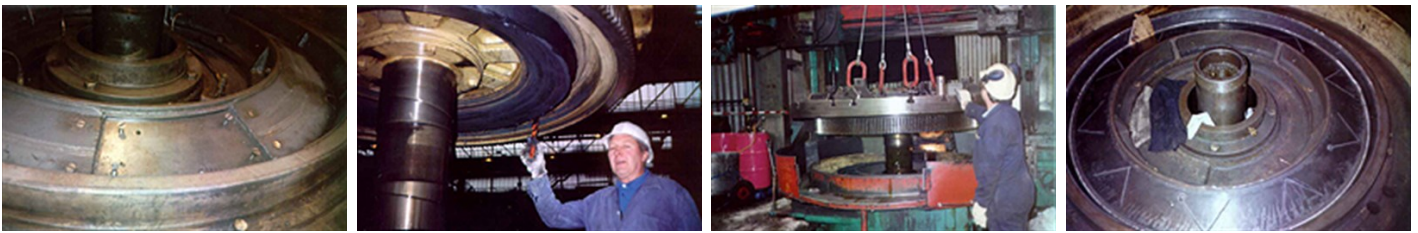
White metal bearing plates badly worn/scored due to oil starvation. Manufacturer of this unit has ceased trading so replacement part is unobtainable.

- * The problem area - excessive wear to white metal plates. ,
- * Application of Belzona® 1131. ,
- * Chuck going back into machine to form Belzona® 1131. ,
- * The finished job with oil grooves cut into Belzona® 1131. ,

The application was carried out in accordance with Belzona Know-How Leaflet MPT-9.

The repaired machine now runs quieter and more smoothly, providing a higher standard of finish to machined components.
