# Belzona makes grit trucks fit for the winter

ID: 1391

Industry: *General Industry*  
Application: *SHM-Solids Handling Machinery*

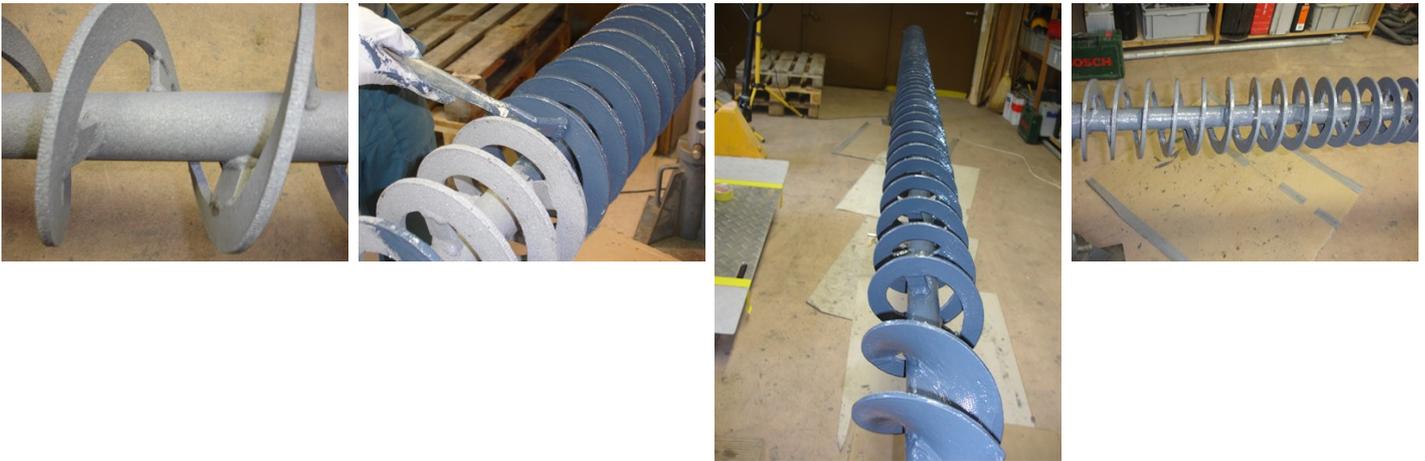
*Auger screws from salt gritting trucks get worn due to the abrasive effect of the salt grit and corrosion resulting in shorter than desired life expectancies.*

- \* Auger screw after grit blasting ,
- \* Application of the first coat of Belzona® 1321 (blue) ,
- \* Finished first coat ,
- \* Finished application with second coat of Belzona® 1321 (grey) ,

The application was carried out in accordance with Belzona Know-How System Leaflet SHM-14. Two coats of Belzona® 1321 were applied to the grit blasted steel substrate.

The pictures show the coating of a new screw auger. This particular application resulted through the success in 2003 of a smaller version of this auger screw, similarly protected with Belzona® 1321. After 6 years the screw was still in service and in good condition and exceeding the customer's expectation.
