Belzona makes grit trucks fit for the winter

Application: SHM-Solids Handling Machinery

Screw auger from a road gritting truck

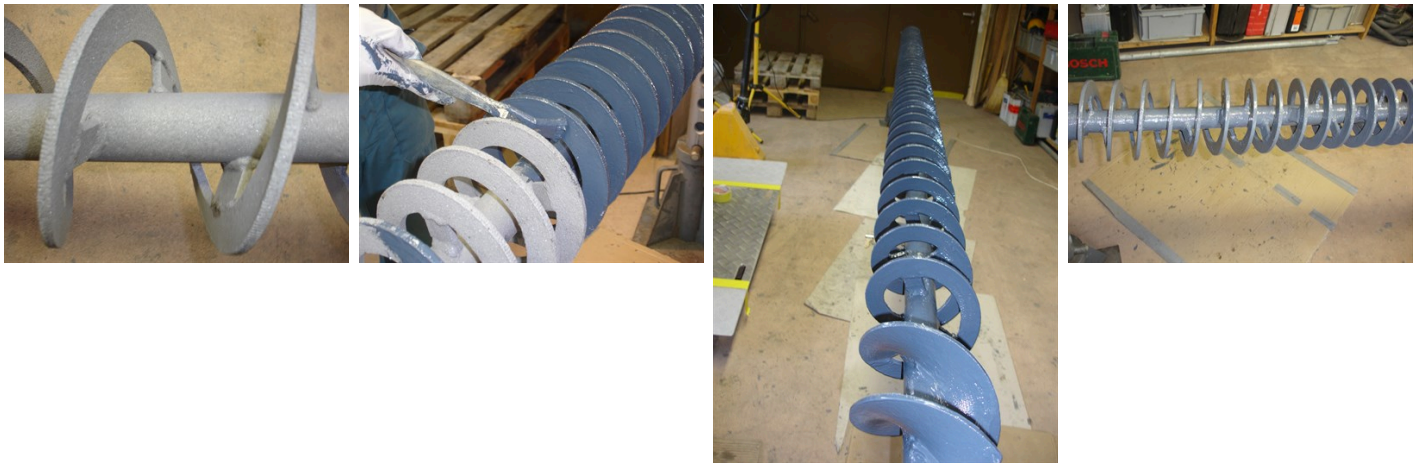
Photograph Descriptions

Auger screws from salt gritting trucks get worn due to the abrasive effect of the salt grit and corrosion resulting in shorter than desired life expectancies.

- * Auger screw after grit blasting ,
- * Application of the first coat of Belzona® 1321 (blue) ,
- * Finished first coat ,
- * Finished application with second coat of Belzona® 1321 (grey) ,

The application was carried out in accordance with Belzona Know-How System Leaflet SHM-14. Two coats of Belzona® 1321 were applied to the grit blasted steel substrate.

The pictures show the coating of a new screw auger. This particular application resulted through the success in 2003 of a smaller version of this auger screw, similarly protected with Belzona® 1321. After 6 years the screw was still in service and in good condition and exceeding the customer's expectation.
