# BELZONA FIXES PILOT BOAT RUBBING STRIP

ID: 1394

Industry: Marine  
Application: SOS-Ships and Offshore Structures

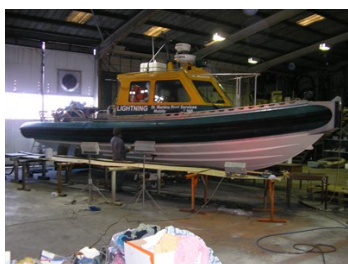
- \* The RIB pilot boat ,
- \* New D section rubbing strip ready to be bonded into place ,
- \* Strip being bonded into place ,
- \* New section bonded on and held in place with tape until Belzona cured ,

Rubbing strip on Rigid Inflatable (RIB) pilot boat.
