BELZONA FIXES PILOT BOAT RUBBING STRIP

ID: 1394

Rubbing strip on Rigid Inflatable (RIB) pilot boat.

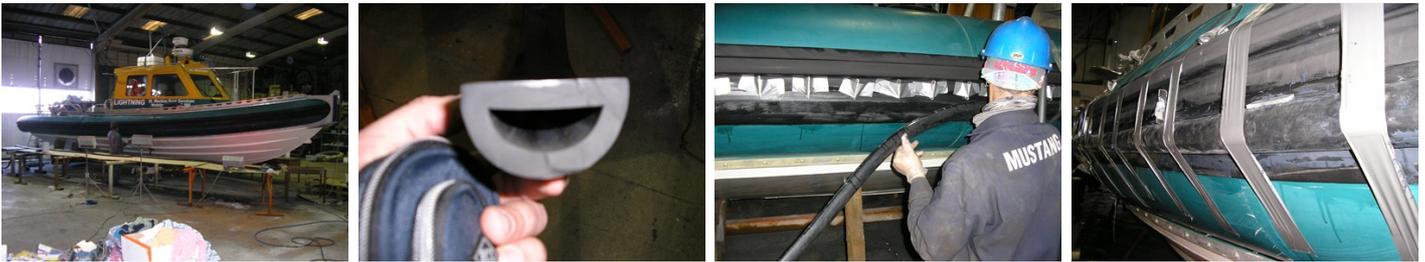
Photograph Descriptions

- * The RIB pilot boat ,
- * New D section rubbing strip ready to be bonded into place ,
- * Strip being bonded into place ,
- * New section bonded on and held in place with tape until Belzona cured ,

Application carried out in accordance with Belzona Know-How System Leaflet SOS-12. after preparing underside of rubbing strip and counterface on hull, the strip was positioned, spacers were used to ensure a level fit, and taped into place until Belzona cured.
