BELZONA PROTECTS CONTACTER TANK

ID: 1396

Industry: Water / Wastewater
Application: TCC-Tanks and Chemical Containment Areas

Customer Location: Water treatment plant, New Jersey
Application Date: 2008

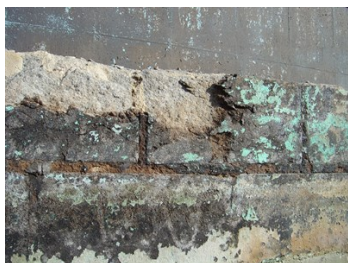
Sodium Hypochlorite vapors had destroyed the concrete walls above the water line. The previous coating, an inexpensive commodity product, failed in this aggressive chemical environment.

- * The deteriorated tops of the concrete wall ,
- * Tops removed and cleaned up ,
- * Belzona® 5111 tinted sky blue. ,
- * Spillway rebuilt with Belzona® 4111 ,
