# BELZONA PROTECTS CONTACTER TANK

**Industry:** Water / Wastewater  
**Application:** TCC-Tanks and Chemical Containment Areas

**Customer Location:** Water treatment plant, New Jersey  
**Application Date:** 2008

Final Chlorine contact tank at municipal waste water plant.

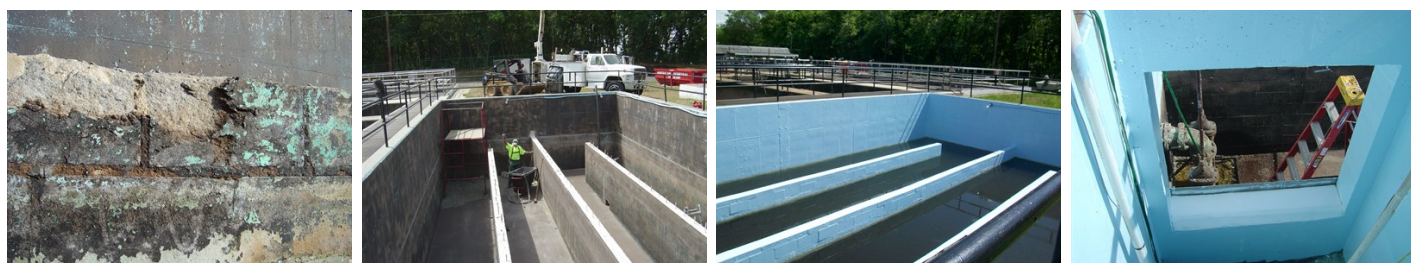
Sodium Hypochlorite vapors had destroyed the concrete walls above the water line. The previous coating, an inexpensive commodity product, failed in this aggressive chemical environment.

- \* The deteriorated tops of the concrete wall ,
- \* Tops removed and cleaned up ,
- \* Belzona® 5111 tinted sky blue. ,
- \* Spillway rebuilt with Belzona® 4111 ,

Application carried out in accordance with Belzona Know-How System Leaflets TCC-9 & WPA-2. The deteriorated tops of the concrete wall were removed and replaced. The walls were then prepared by grit-blasting before applying the Belzona® 5111 system (tinted blue). Belzona® 4111 was used to repair the spillway.
