BAROMETRIC CONDENSER PROTECTED WITH BELZONA

ID: 1397

Customer Location: Oil Refinery, Pennsylvania USA
Application Date: November 2008

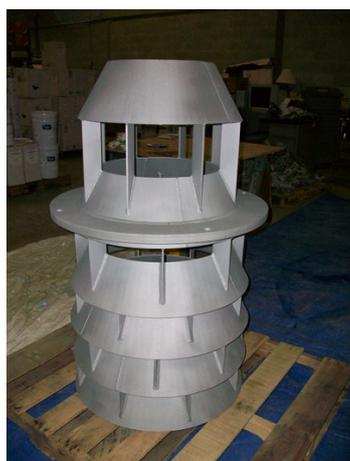
- * White metal blast ,
- * Additional components after blasting ,
- * Condenser coated ,
- * Coated flange face ,

Application was carried out in accordance with Belzona Know-How System Leaflet HEX-3.
