# BELZONA SEALS JOINTS ON COOLING TOWER

Customer Location: Nuclear Power Plant in the Northeast,  
U.S.A.

Application: HEX-Heat Exchangers

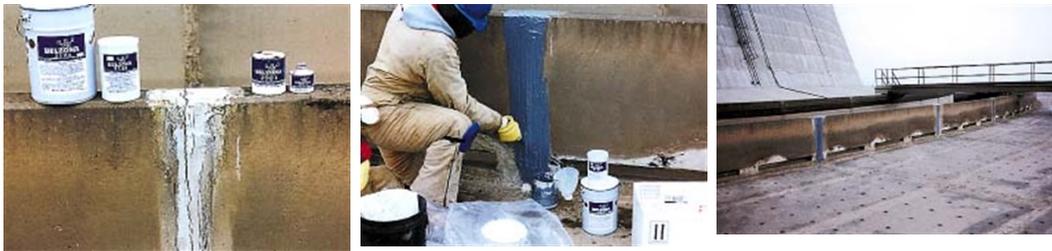
Leaking joints prevented tower de-icing system to function properly, resulting in ice damage to concrete tower.

- \* The damaged expansion joint sealant. ,
- \* Application in progress. ,
- \* All joints sealed. ,

Expansion joints on natural draft cooling tower.

Application was carried out in accordance with a modified version of Belzona Know-How Leaflet HEX-13b.

All repair work was completed during a scheduled plant outage. The Belzona system was installed at 18°F. Inspection 18 months later revealed excellent performance.
