# BELZONA KEEPS HOSPITAL LAUNDRY BILLS DOWN

**Industry:** General Industry  
**Application:** VPF-Valves, Pipes and Fittings  
**Substrate:** Rubber  
**Products:** \* Belzona® 2211 (MP Hi-Build Elastomer) ,

**Customer Location:** Hospital  
**Application Date:** Ongoing since 1994

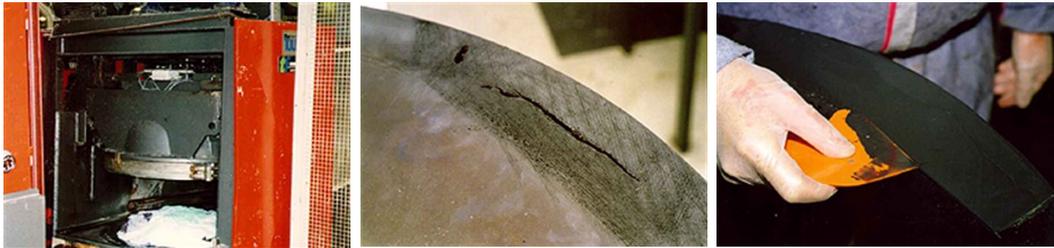
*Wear and tear in service causes splits, in addition to mechanical damage caused by sharp objects left in clothing (a common occurrence).*

- \* The laundry press in operation ,
- \* Typical split prepared and ready to have Belzona® applied ,
- \* Completing the Belzona® 2211 application ,

Press used to squeeze water from laundry prior to drying. They operate at pressures up to 270 bar.

Application was carried out in accordance with Belzona System leaflet VPF-5.

Typical Belzona repairs cost £10-20 as opposed to a new diaphragm at over £1400. At this hospital some diaphragms have been repaired 5 and 6 times.
