# BELZONA REPAIRS RUBBER LINED SLURRY PUMPS

ID: 1406

Application: SHM-Solids Handling Machinery

Customer Location: Power Plant, Mooresville, NC

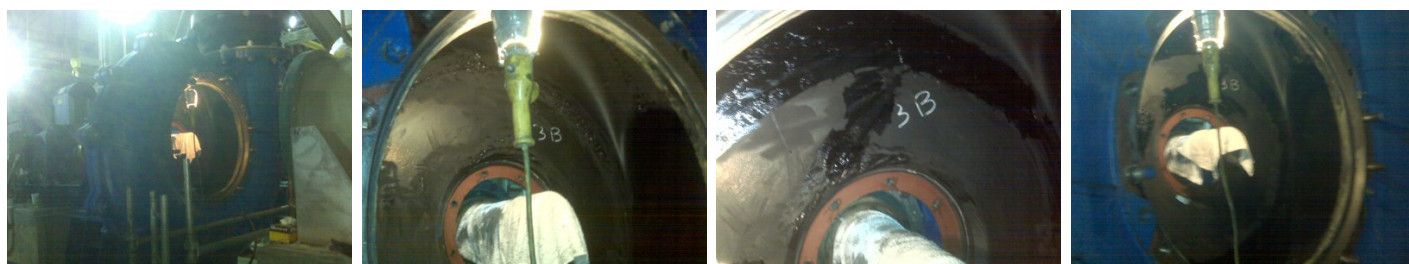
## Photograph Descriptions

Areas on the inside of the pump were gouged and worn by the lime slurry.

- \* The pump to be worked on ,
- \* Damage caused by the lime slurry ,
- \* Close up of Belzona® 2111 repairs ,
- \* The pump with the repairs completed ,

The application was carried out in accordance with Belzona Know-How System Leaflet SHM-11. The substrate was roughened using a rotary wire brush and scuffing tool. The damaged areas were conditioned and then the Belzona® 2111 applied to restore profiles.
