BELZONA SOLVES KITCHEN TRIP HAZARD

Industry: Buildings & Structures
Application: FPA-Floor Problem Areas
Substrate: Concrete, rubber and tile
Products: * Belzona® 4111 (Magma Quartz) ,

Customer Location: Hospital, Charlotte, North Carolina USA
Application Date: January, 2009

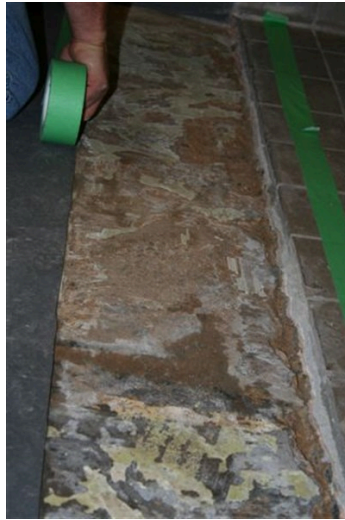
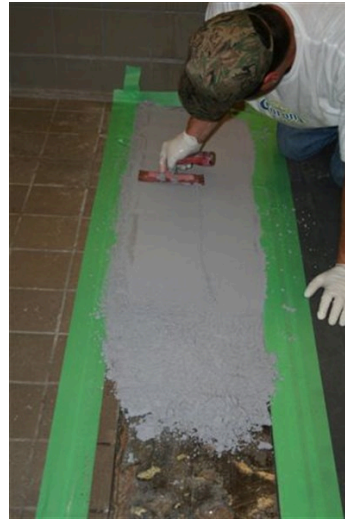
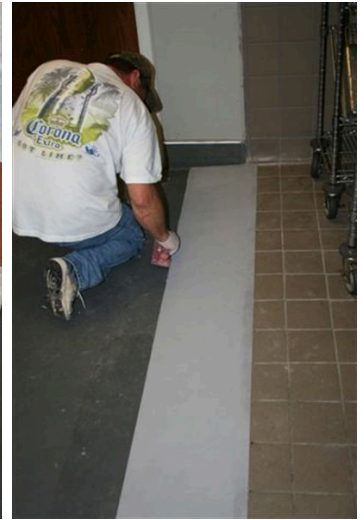
Photograph Descriptions

There is a big transition which was causing a trip hazard as well as limiting cart traffic.

- * Coin shows the transition step ,
- * Exposed concrete after rubber floor removal. ,
- * Applying the Belzona 4111 ,
- * The finished job ,

Transition between a rubber floor and a tiled floor.

The application was carried out in accordance with Belzona Know-How System Leaflets FPA-1 & -5. The rubber floor was cut out so a slope could be made from the edge of the rubber floor to the tile so that a smooth transition could be created.
