BELZONA LOW COST MAINTENANCE OF PRESS PADS

ID: 141

Customer Location: *Aircraft manufacturer*
Application Date: *March 1997*

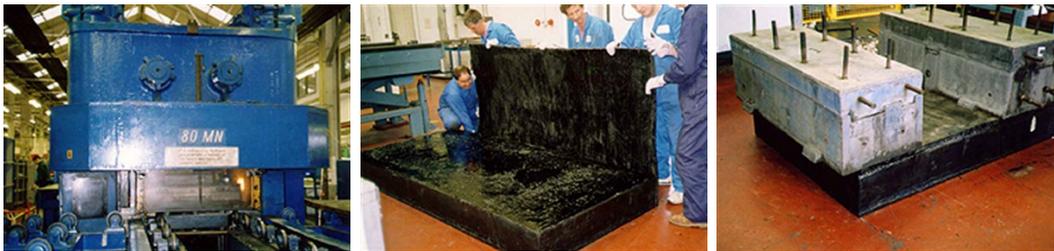
Photograph Descriptions

Wear and cutting of the rubber bolster during the forming process leading to loss of accuracy in the formed components.

- * General view of the press ,
- * The resurfacing pad being positioned over the bolster with both surfaces treated with Belzona® 2131 ,
- * Weights in place whilst Belzona® 2131 cures ,

Instead of replacing complete bolster a 1-inch (25 mm) thick rubber pad is bonded to the surface in accordance with Belzona System leaflet GSS-2.
