CAVITATION PROTECTION FOR WATER PUMPS WITH BELZONA

ID: 1414

Customer Location: *Water treatment plant, Egypt*

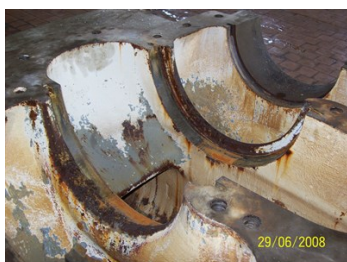
General erosion/corrosion damage and severe cavitation leads to reduced pump efficiency.

- * General view of the pumps ,
- * Erosion/Corrosion damage ,
- * The cavitation area after blasting ,
- * Completed application ,

Application was carried out in accordance with Belzona Know-How System Leaflets CEP-3 & CEP-5
