# CAVITATION PROTECTION FOR WATER PUMPS WITH BELZONA

**Industry:** Fluid Flow  
**Application:** CEP-Centrifugal Pumps  
**Substrate:** Cast iron  
**Products:** \* Belzona 1311 (Ceramic R-Metal) ,  
\* Belzona 1341N (Supermetalglide) ,  
\* Belzona 2141 (ACR-Fluid Elastomer) ,

**Customer Location:** Water treatment plant, Egypt  
**Application Date:** 2008

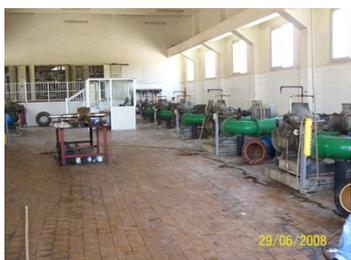
General erosion/corrosion damage and severe cavitation leads to reduced pump efficiency.

- \* General view of the pumps ,
- \* Erosion/Corrosion damage ,
- \* The cavitation area after blasting ,
- \* Completed application ,

Belzona repaired the cavitation areas and protected the pumps from further cavitation.
