CAVITATION PROTECTION FOR WATER PUMPS WITH BELZONA

Customer Location: *Water treatment plant, Egypt*
Application Date: *2008*

End suction centrifugal Water pumps

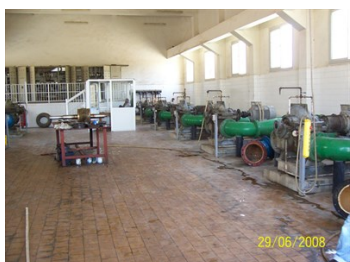
- * General view of the pumps ,
- * Erosion/Corrosion damage ,
- * The cavitation area after blasting ,
- * Completed application ,

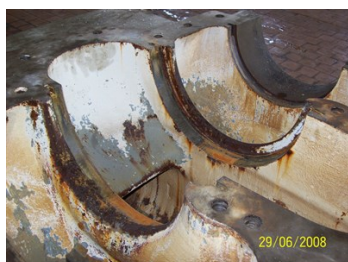
General erosion/corrosion damage and severe cavitation leads to reduced pump efficiency.
