Belzona repairs casing of a cement ball mill

ID: 1417

Industry: *Cement*
Application: *SHM-Solids Handling Machinery*

Customer Location: *Cement plant, Egypt*
Application Date: *November 2008*

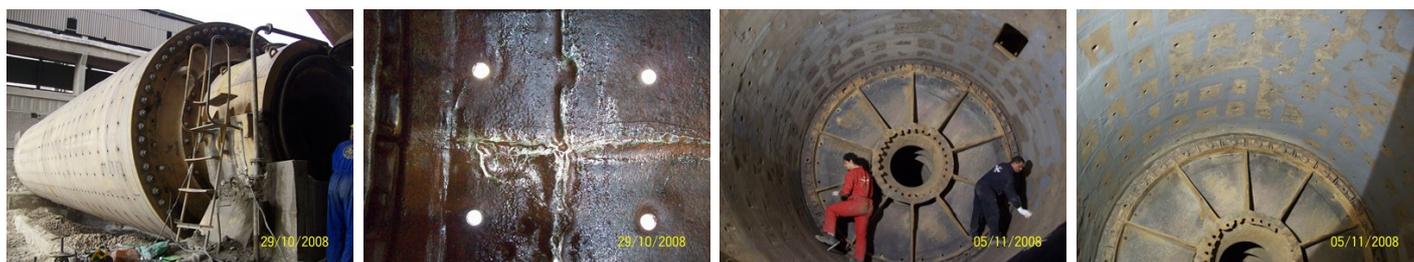
Photograph Descriptions

Wear on the casing needed to be rebuilt before the bolting of the new wear plates.

- * General view of the mill. ,
- * Wear on the shell after dismantling the plates. ,
- * Application of Belzona® 1121. ,
- * Completed application. ,

Application was carried out in accordance with Belzona Know-How System Leaflet SHM-7.
