BELZONA RESTORES COOLING WATER PUMP

ID: 1419

Application: CEP-Centrifugal Pumps

Customer Location: Refinery, Texas USA

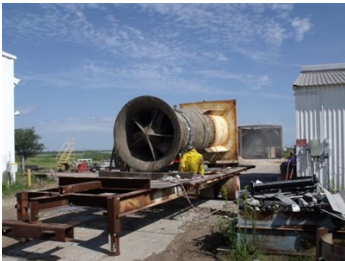
- * Circulating water pump ,
- * Damaged suction bell ,
- * Impeller coated with Belzona® 1341 together with rebuilt and coated suction bell ,
- * Pump discharge coated with Belzona® 1341 ,

Main circulating water pump at refinery.

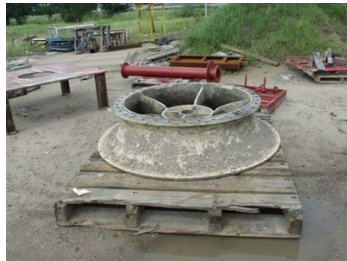
General corrosion over many years had degraded the operation of the pump.

Application was carried out in accordance with Belzona Know-How System Leaflets CEP-1 & -3. All pitting was rebuilt with Belzona® 1111. After the rebuild was complete two coats of Belzona® 1341 applied.
