# BELZONA RESTORES COOLING WATER PUMP

ID: 1419

Customer Location: Refinery, Texas USA  
Application Date: Fall of 2009

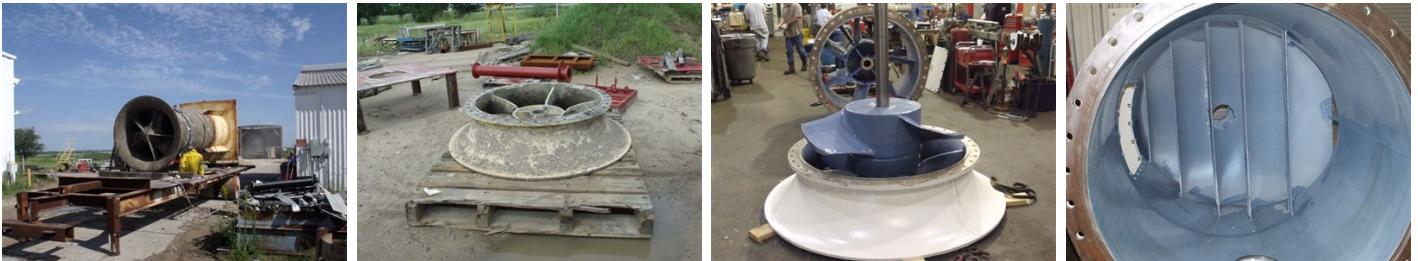
General corrosion over many years had degraded the operation of the pump.

- \* Circulating water pump ,
- \* Damaged suction bell ,
- \* Impeller coated with Belzona® 1341 together with rebuilt and coated suction bell ,
- \* Pump discharge coated with Belzona® 1341 ,

Application was carried out in accordance with Belzona Know-How System Leaflets CEP-1 & -3. All pitting was rebuilt with Belzona® 1111. After the rebuild was complete two coats of Belzona® 1341 applied.
