BELZONA® REFURBISHMENT OF VACUUM PUMP

ID: 142

Application: *PDP-Positive Displacement Pumps*

Siemens Elmo vacuum pump from drum filter

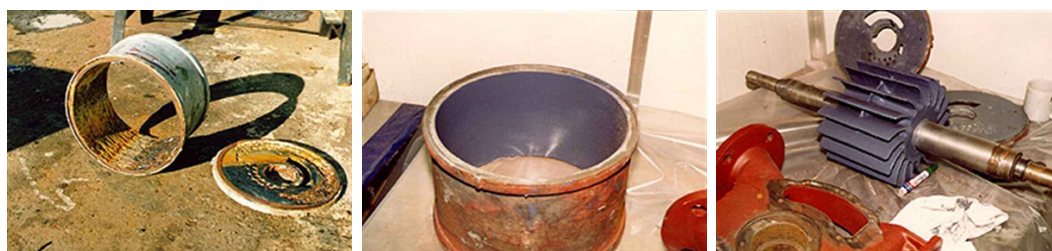
Photograph Descriptions

Severe erosion corrosion of port plates, body and rotor caused by poor quality sealing water resulting in corrosion, plus carry over of diatomaceous earth causing erosion.

- * The degree of erosion corrosion clearly evident on the port plates and body ,
- * The restored body ,
- * The coated rotor with reformed port plates in background ,

Application was carried out in accordance with Belzona Know-How leaflets PDP-5 and FBC-11. Port plates were restored by forming correct dimensions and critical areas on the body were re-built and machined to size before coating with Belzona® 1321
