# **BELZONA KEEPS OS&D HOSE IN SERVICE**

| Industry: | Marine |
|---|--|
| Application: | SOS-Ships and Offshore Structures |
| Substrate: | Rubber and exposed fabric reinforcement |

Customer Location: Liquid bulk storage terminal, NJ Application Date: October 2009

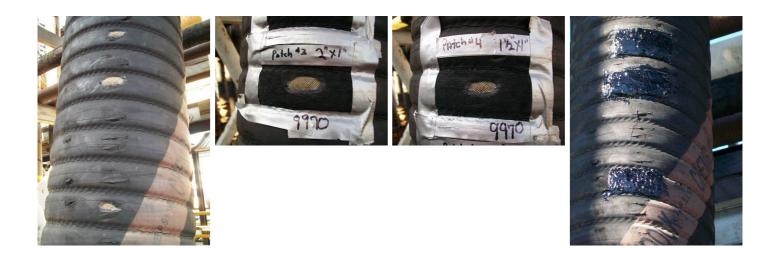
### **Photograph Descriptions**

When inspected by the United States Coast Guard, even superficial scuffs and tears in the outer cover can result in hoses being tagged "out of service". Inspection showed that the reinforcement fabric had not been damaged.

- \* Hose #9970 with 3 scuffed up areas exposing reinforcement fabric ,
- \* Patch #3 area taped off and abraded ,
- \* Patch #4 area taped off with Conditioner applied ,
- \* Completed and ready for inspection ,

Scuffs and tears to the cover of 8" OS&D (Oil Suction & Discharge) hoses.

Application was carried out in accordance with Belzona Know-How System Leaflet SOS-12.

A typical 8" OS&D hose can cost \$3500 depending on length. Superficial damage, meaning damage to cover only, is common when dragged over docks and railings. The Coast Guard, however, can require these hoses be retired from service. If there is no damage to the reinforcement fabrics, a Belzona® 2111 patch system, when fully documented with before and after pictures, has been accepted by the USCG. These specific patches cost approx \$1200 in material and labor. 5 patches were installed on three hoses saving the customer approx \$11,000 in replacement costs
