# BELZONA REPAIRS CONDENSOR WATER TUBES

**Industry:** Chemical & Petrochemical  
**Application:** VPF-Valves, Pipes and Fittings  
**Substrate:** Carbon steel  
**Products:** \* Belzona® 1111 (Super Metal) ,  
\* Belzona® 1291 (ES Metal) ,  
\* Belzona® 1161 (Super UW Metal) ,

**Customer Location:** Chemical Plant, Lithuania  
**Application Date:** December 2009

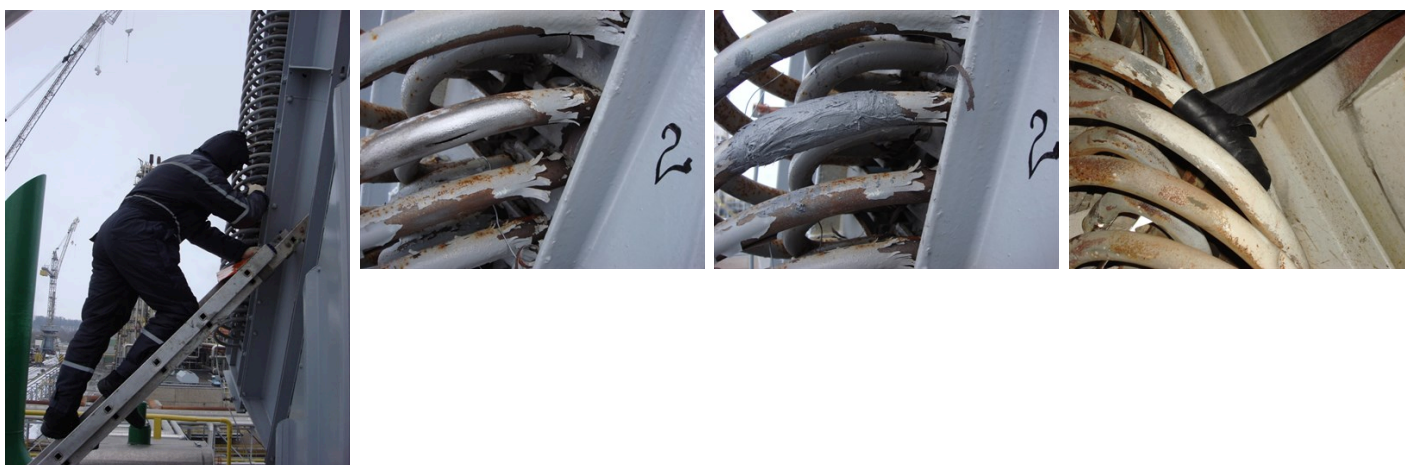
## Photograph Descriptions

There were leaks on the condensor water tubes. Plant engineers had tried different solutions but none of them were totally effective.

- \* Removing loose material and paint ,
- \* Surface preparation of the substrate ,
- \* Application of Belzona® 1111 with Belzona® 9341 (Reinforcement Tape) ,
- \* Belzona® 1291 with tourniquet used to seal live leak ,

Various leaks on external pipes to condensers

Application was carried out in accordance with Belzona® Know-How System Leaflet VPF-11a.

Belzona® 1161 was most suitable product on wet surfaces and Belzona® 1111 for dry surfaces. In one area where the pressure was 0,7-1 bar Belzona® 1291 used with touniquet to stop the live leak.
