# BELZONA REPAIRS AND REBUILDS POWER PLANT CONDENSER

ID: 1430

Customer Location: Power Plant, Russia

Application Date: August 2009

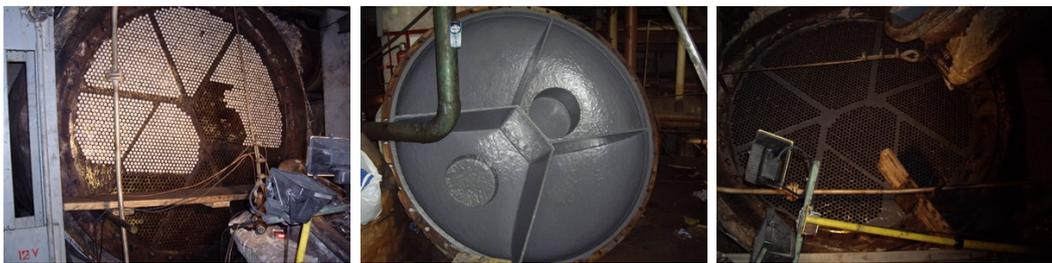
Inspection during the plant shutdown, showed severe corrosion on the heat exchanger with poor sealing on division bars and seal faces.

- \* Surface preparation of tubesheet ,
- \* Rebuilt and coated water box ,
- \* Completed application to tubesheet ,

Tubesheet and waterboxes of power station condenser.

Application was carried out in accordance with Belzona Know-How System Leaflets HEX-1, 2 & 4.

Belzonas trained specialists have good experiences with the customer. The efficiency of the heat exchanger was economically restored and protected from future corrosion problems.
