BELZONA SAVES FINE PAPER PUMP CASING

ID: 1432

Industry: *Pulp & Paper*
Application: *CEP-Centrifugal Pumps*
Substrate: *Cast Iron*
Products: ** Belzona® 1321 (Ceramic S -Metal) ,*

Customer Location: *Papermill, Port Elizabeth, South Africa.*
Application Date: *2009*

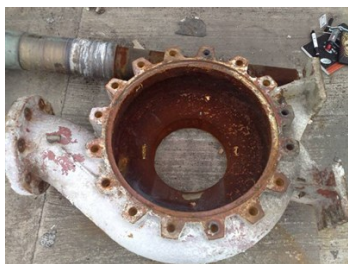
Badly corroded pump volute could not be put back in service in such bad condition

- * Corroded Pump Volute before application ,
- * Volute coated with Belzona® 1321 ,
- * The refurbished pump volute ready for service ,
- * ,
