BELZONA SAVES FINE PAPER PUMP CASING

Industry: *Pulp & Paper*
Application: *CEP-Centrifugal Pumps*
Substrate: *Cast Iron*
Products: ** Belzona® 1321 (Ceramic S -Metal) ,*

Customer Location: *Papermill, Port Elizabeth, South Africa.*
Application Date: *2009*

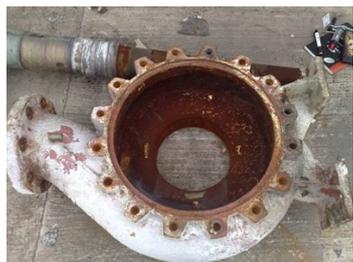
Badly corroded pump volute could not be put back in service in such bad condition

- * Corroded Pump Volute before application ,
- * Volute coated with Belzona® 1321 ,
- * The refurbished pump volute ready for service ,
- * ,

The application was carried out in accordance with Belzona Know-How System Leaflet CEP-5.
