# BELZONA SAVES FINE PAPER PUMP CASING

Industry: *Pulp & Paper*  
Application: *CEP-Centrifugal Pumps*  
Substrate: *Cast Iron*  
Products: *\* Belzona® 1321 (Ceramic S -Metal) ,*

Customer Location: *Papermill, Port Elizabeth, South Africa.*  
Application Date: *2009*

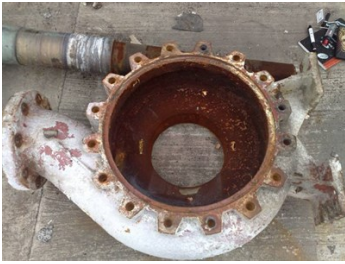
*Badly corroded pump volute could not be put back in service in such bad condition*

- \* Corroded Pump Volute before application ,
- \* Volute coated with Belzona® 1321 ,
- \* The refurbished pump volute ready for service ,
- \* ,

The application was carried out in accordance with Belzona Know-How System Leaflet CEP-5.
