CONVEYOR ROLLERS ON DREDGER RESTORED WITH BELZONA

ID: 1433

Industry: *Marine*
Application: *SOS-Ships and Offshore Structures*

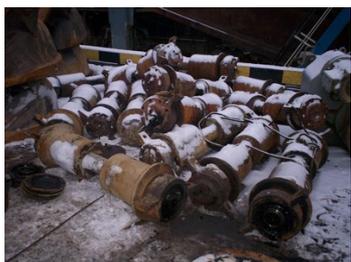
After dismantling, 17 rollers were revealed to be damaged especially bearings, shaft journal and mounting seats.

- * General view of dismantled rollers ,
- * View of the defects on the rollers ,
- * & 4. A completed application ,
