# BELZONA RESURFACES BRAKE TEST ROLLERS

ID: 1435

Customer Location: *State Road Transport Research Institute,  
Ukraine*

Application: *SHM-Solids Handling Machinery*

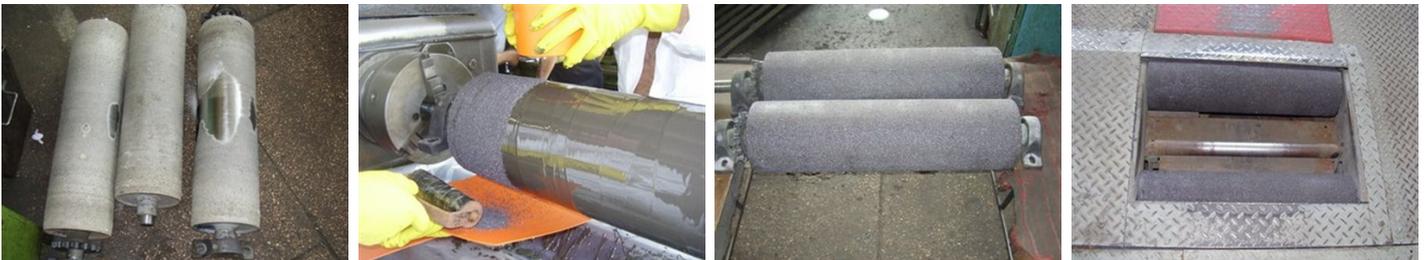
## Photograph Descriptions

*Worn original anti-slip coating on the brake rollers.*

- \* The worn brake test rollers ,
- \* Application of Belzona Grip system ,
- \* Completed application ,
- \* Picture after 2 years in service and more than 12,000 brake tests ,

Rollers of the Brekon 131-4S type car brake testing rig.

The application was carried out in accordance with Belzona Know-How System Leaflet SHM-12.

Belzona application avoided the replacement costs and outage of equipment. Between 2007 and 2009, more than 12.000 brake tests have been carried out, which was a very satisfactory result for the client. A Testimonial letter is available from the customer about this application.
