# BELZONA PROTECTS PROPULSION UNIT ON FERRY

ID: 1436

Customer Location: *Ferry, Ontario, Canada*  
Application Date: *February, 2010*

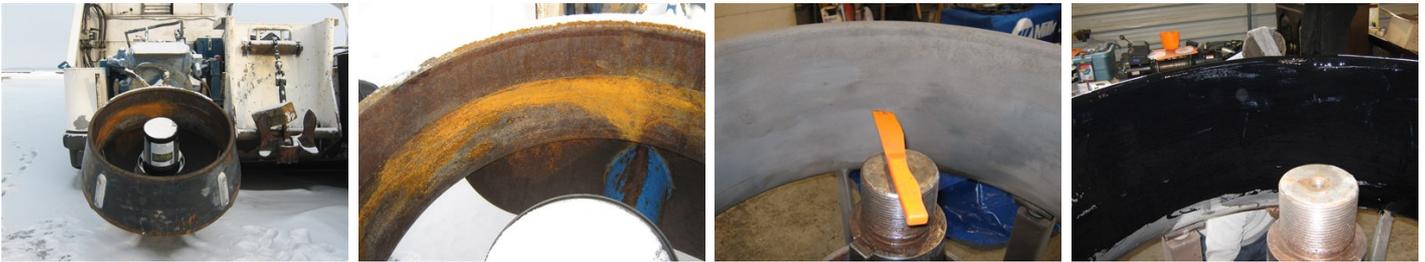
*Erosion had worn through nozzle. Welding considered but high risk of distortion and expensive.*

- \* Rolls Royce drive unit on Ferry ,
- \* Nozzle of drive showing corrosion and erosion from cavitation ,
- \* Inner surface grit blasted and erosion damage built up using Belzona® 1311 ,
- \* Application of Belzona® 2141 completed ,

Nozzle of drive unit eroded due to cavitation.

Application was carried out in accordance with Belzona Know-How System Leaflets SOS-1 & 2. After grit blasting, Belzona® 1311 was used to replace eroded metal. Belzona® 2141 system was then applied to the nozzle extending the application over both the leading and trailing edges to give maximum protection.
