# BELZONA PROTECTS AUGER SCREWS AT CEMENT PLANT

Application: SHM-Solids Handling Machinery

Customer Location: Cement Producer, Lithuania

Coal transporter at cement plant.

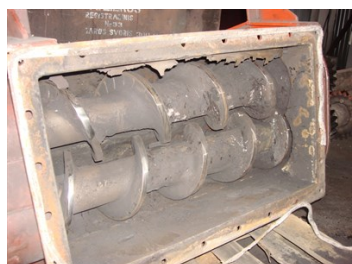
The auger screws suffer severe abrasion and client needed an effective protection system.

- \* General view of screws after 1 year in service ,
- \* The view after surface preparation ,
- \* Belzona® 1812 application on both sides of helical outer surfaces ,
- \* Belzona® 1321 application and completed job ,
