BELZONA RESTORES PUMP FROM SUGAR MILL

ID: 1439

Customer Location: *Major Sugar Producer, South Africa*
Application Date: *March 2010*

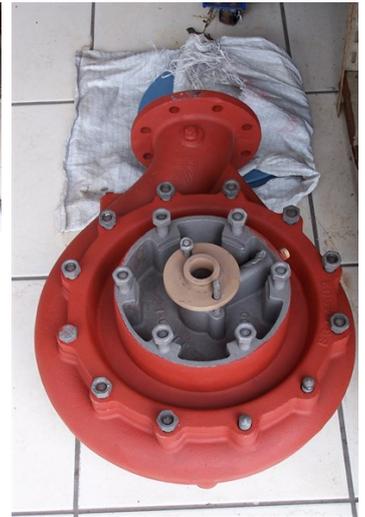
Customer looking to repair badly eroded back plate & volute and to coat new Impeller

- * Pump after grit blasting ,
- * Baddly worn cut water and hole through volute ,
- * Finished Application ,
- * Pump assembled and ready for despatch ,

Pump handling Condensate at 80 °C

Application was carried out in accordance with Belzona Know-How System Leaflets CEP-1, 3 & 5.

Conventional weld repairs difficult on cast iron. Belzona provides effective rebuild and restoration of profiles without risk of distortion and Belzona® 1391 provides excellent erosion corrosion protection at the pumps 80 °C operating temperature.
