# BELZONA PROVEN CAVITATION PROTECTION TO FRANCIS TURBINE

ID: 1441

Customer Location: Hydroelectric plant, Slovakia  
 Application Date: 2004 and 2007

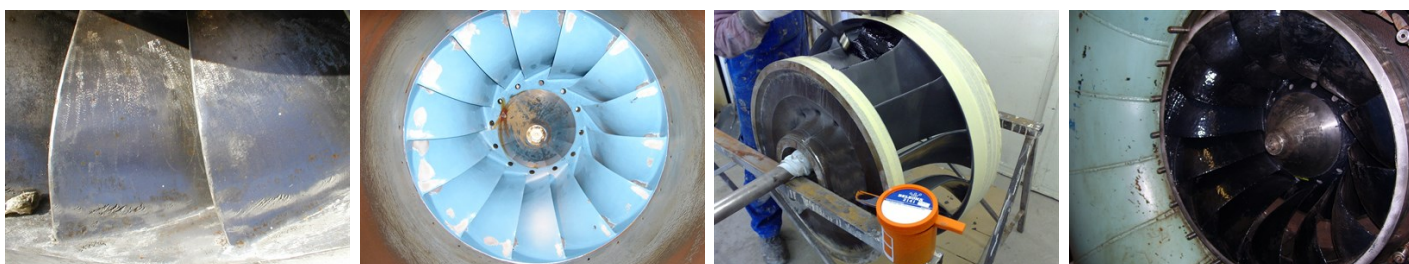
Cavitation had caused erosion of the metal and loss of turbine performance. Belzona® 1311 and Belzona® 1341 had been applied in 2004, but had suffered further cavitation, so system upgraded by applying more cavitation resistant Belzona® 2141.

- \* Cavitation damage to turbine runner ,
- \* Belzona® 1341 showing some cavitation damage ,
- \* Belzona® 2141 being applied to the runner ,
- \* After 24 months service Belzona® 2141, inspection shows no further cavitation damage ,

Inspection of the Belzona Ceramic coating in 2006 showed damage from cavitation, so specification was changed to Belzona® 2141. Further inspection after 2 years showed no damage on the turbine runner.

In 2013 small areas of coating damage were repaired with further Belzona 2141.
