# BELZONA PROTECTS A POWER STATION CHIMNEY STACK

Customer Location: Coal Fired Power Station, Yorkshire, England

Top section of exhaust gas chimney stack.

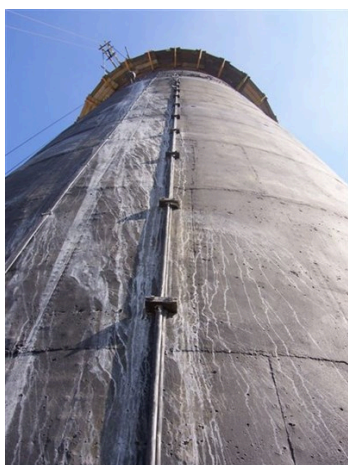
Existing coating was beginning to degrade due to exhaust gases and ultra-violet (UV) breakdown combined with inclement weather.

\* Existing coating degrading Application of Belzona® 5111 Completed application in 2008 Application revisited in 2010 ,

Application was carried out in accordance with modified Belzona Know-How System Leaflet WPA-2. Deteriorated bituminous coating was removed by grit blasting. Cracks and spalled concrete was rebuilt with Belzona® 4141 before coating with Belzona® 5111.
