# BELZONA PROTECTS A POWER STATION CHIMNEY STACK

Customer Location: Coal Fired Power Station, Yorkshire, England

Application: WPA-Wall Problem Areas

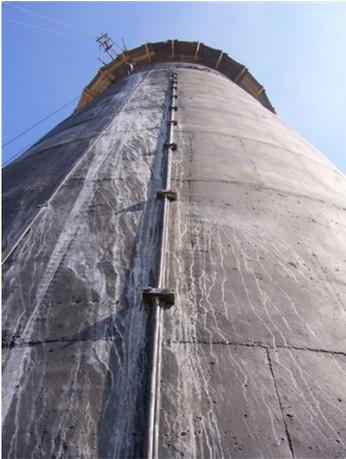
Existing coating was beginning to degrade due to exhaust gases and ultra-violet (UV) breakdown combined with inclement weather.

\* Existing coating degrading Application of Belzona® 5111 Completed application in 2008 Application revisited in 2010 ,

Application was carried out in accordance with modified Belzona Know-How System Leaflet WPA-2. Deteriorated bituminous coating was removed by grit blasting. Cracks and spalled concrete was rebuilt with Belzona® 4141 before coating with Belzona® 5111.
