COOLING TOWER FAN BLADES REPAIRED WITH BELZONA PRODUCTS

ID: 1445

Customer Location: Fertilizer Producer, Indonesia
Application Date: February 2010

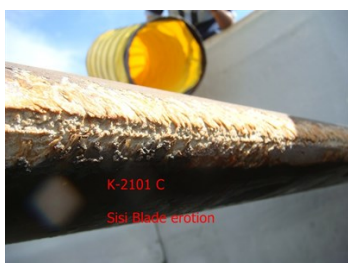
Erosion on leading edges, cracks and flaking on trailing edges of cooling tower fan blades caused by UV degradation, erosion and impingement. This reduces the overall efficiency and operation of the cooling system.

- * Damage on leading edges ,
- * Flaking on trailing edges ,
- * Belzona application ,
- * Completed blades after coating with Belzona® 1321 and Belzona® 5811 ,

The application was carried out in accordance with Belzona Know-How System Leaflet FBC-1. The Leading edges and trailing edges were rebuilt with Belzona® 1311 and subsequently coated with Belzona® 1321. Blade body was coated using Belzona® 5811.
