# COOLING TOWER FAN BLADES REPAIRED WITH BELZONA PRODUCTS

ID: 1445

Customer Location: *Fertilizer Producer, Indonesia*  
Application Date: *February 2010*

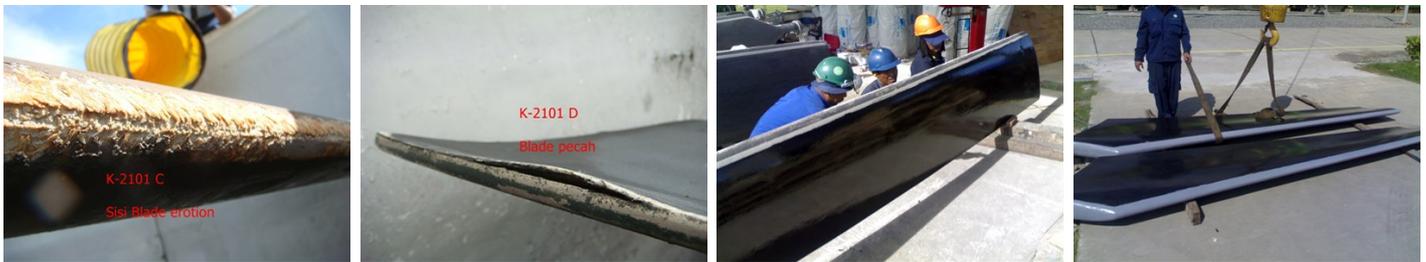
*Erosion on leading edges, cracks and flaking on trailing edges of cooling tower fan blades caused by UV degradation, erosion and impingement. This reduces the overall efficiency and operation of the cooling system.*

- \* Damage on leading edges ,
- \* Flaking on trailing edges ,
- \* Belzona application ,
- \* Completed blades after coating with Belzona® 1321 and Belzona® 5811 ,

The application was carried out in accordance with Belzona Know-How System Leaflet FBC-1. The Leading edges and trailing edges were rebuilt with Belzona® 1311 and subsequently coated with Belzona® 1321. Blade body was coated using Belzona® 5811.
