# FAN BLADES RESTORED WITH BELZONA SYSTEM

ID: 1446

Customer Location: *Geothermal power plant, Indonesia*  
Application Date: *March, 2009*

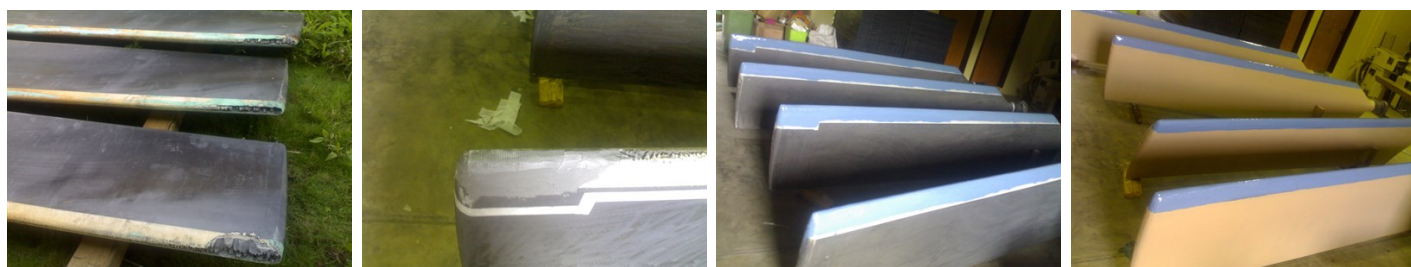
*Damage and erosion on the leading edges of the blades reduced the overall efficiency and operation of the cooling system.*

- \* Damaged cooling tower blades ,
- \* Repair using Belzona® 1111 in progress ,
- \* Belzona® 1341 applied to leading edge of blades ,
- \* Finished repair with Belzona® 5811 applied to blade bodies ,

The client had no other alternative and Belzona saved them time and increased efficiency. Belzona® 1341 provides a smooth erosion resistant lining for the leading edge of the fan blades extending maintenance life of the fans.
