FAN BLADES RESTORED WITH BELZONA SYSTEM

ID: 1446

Customer Location: Geothermal power plant, Indonesia
Application Date: March, 2009

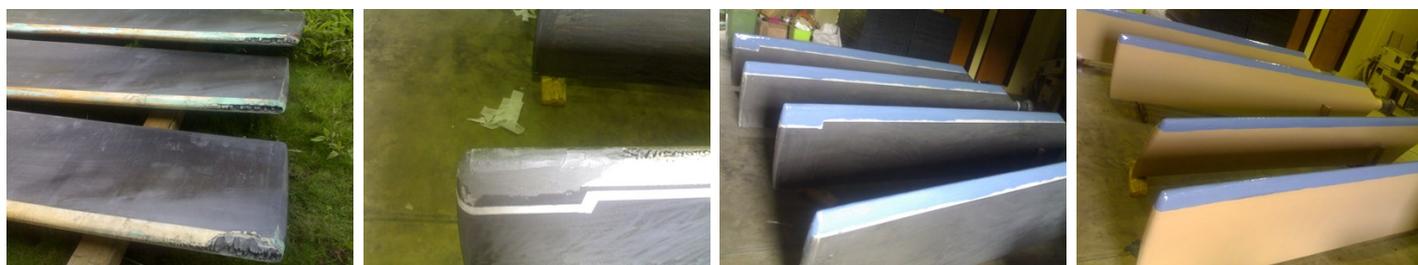
Damage and erosion on the leading edges of the blades reduced the overall efficiency and operation of the cooling system.

- * Damaged cooling tower blades ,
- * Repair using Belzona® 1111 in progress ,
- * Belzona® 1341 applied to leading edge of blades ,
- * Finished repair with Belzona® 5811 applied to blade bodies ,

Fan blades from mechanical draft cooling tower

The client had no other alternative and Belzona saved them time and increased efficiency. Belzona® 1341 provides a smooth erosion resistant ling for the leading edge of the fan blades extending maintenance life of the fans.
