# BELZONA REPAIRED STEPS IN GREAT CONDITION AFTER 5 YEARS

Industry: Buildings & Structures  
Application: FPA-Floor Problem Areas  
Substrate: Concrete  
Products: \* Belzona® 4131 (Magma Screed) ,

Customer Location: Local City Council, N.East England  
Application Date: May 2005

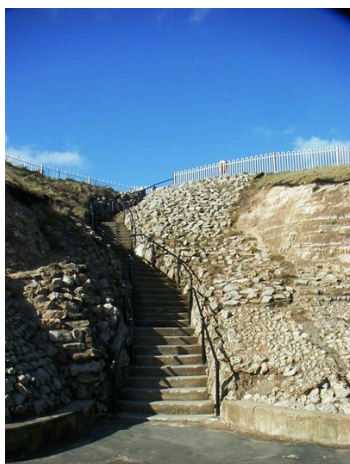
Due to the steps being on the sea front, over a number of years they had deteriorated where the nosings were damaged and in dangerous condition.

- \* Steps before repair ,
- \* Immediately after repair ,
- \* Steps after 5 years use ,
- \* Close up showing no deterioration after 5 years. ,

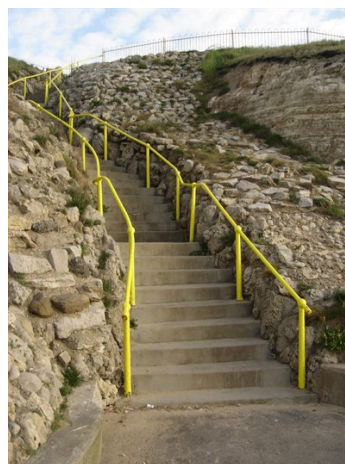
were not effective due to poor adhesion and the nature of the coastal environment. An inspection of the Belzona repairs was carried out after 5 years and there is no signs of deterioration or damage to the step nosings.
