# BELZONA REPAIRED STEPS IN GREAT CONDITION AFTER 5 YEARS (2)

Industry: Buildings & Structures  
Application: FPA-Floor Problem Areas  
Substrate: Concrete  
Products: \* Belzona® 4131 (Magma Screed) ,

Customer Location: Local City Council - N.East England  
Application Date: May 2005

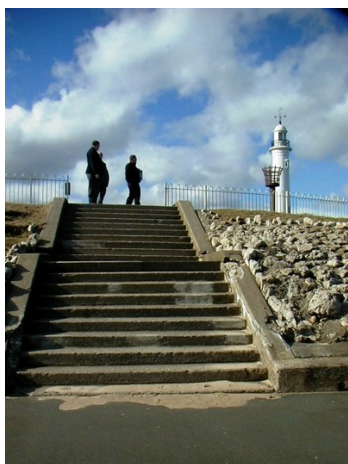
*Due to the promenade steps being on the sea front, over a number of years they had deteriorated where the nosings were damaged and in dangerous condition.*

- \* Steps before repair in May 2005 ,
- \* Steps immediately after repair in May 2005 ,
- \* Steps five years on in May 2010 ,
- \* Further view of steps after five years service. ,

Application was carried out in accordance with Belzona Know-How System Leaflet FPA-1.

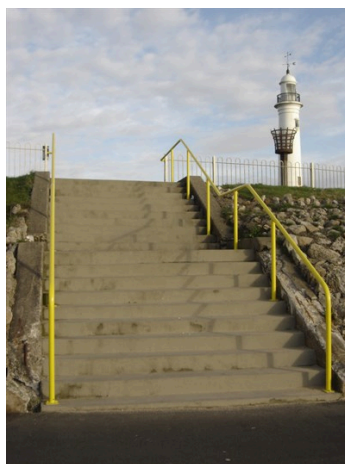
not effective due to poor adhesion and the nature of the coastal environment. An inspection of the Belzona application was carried out after 5 years and there is no signs of deterioration or damage to nosings whatsoever.
