# BELZONA REPAIRED STEPS IN GREAT CONDITION AFTER 5 YEARS (2)

Industry: Buildings & Structures  
Application: FPA-Floor Problem Areas  
Substrate: Concrete  
Products: \* Belzona® 4131 (Magma Screed) ,

Customer Location: Local City Council - N.East England  
Application Date: May 2005

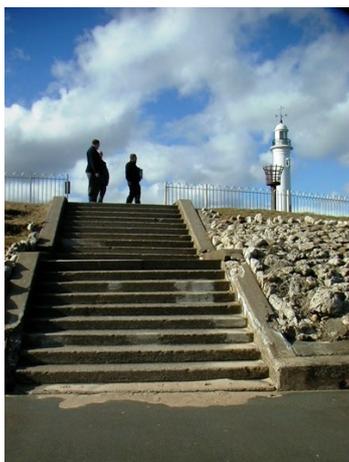
Due to the promenade steps being on the sea front, over a number of years they had deteriorated where the nosings were damaged and in dangerous condition.

- \* Steps before repair in May 2005 ,
- \* Steps immediately after repair in May 2005 ,
- \* Steps five years on in May 2010 ,
- \* Further view of steps after five years service. ,

Application was carried out in accordance with Belzona Know-How System Leaflet FPA-1.

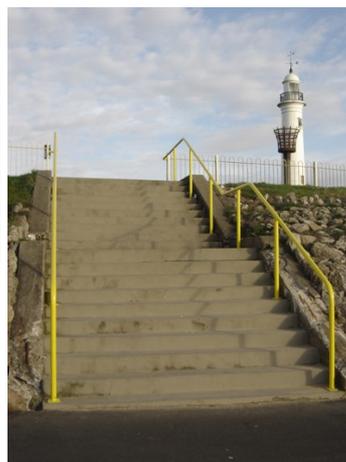
not effective due to poor adhesion and the nature of the coastal environment. An inspection of the Belzona application was carried out after 5 years and there is no signs of deterioration or damage to nosings whatsoever.
